# Facilities Condition Assessment

**Temple Beth Israel  
2090 Hollywood Drive  
York, PA**

**JDB Engineering, Inc.  
PO Box 22160  
York, PA 17402  
Phone: 717-757-5602**

December 8, 2020  
Copyright © 2020

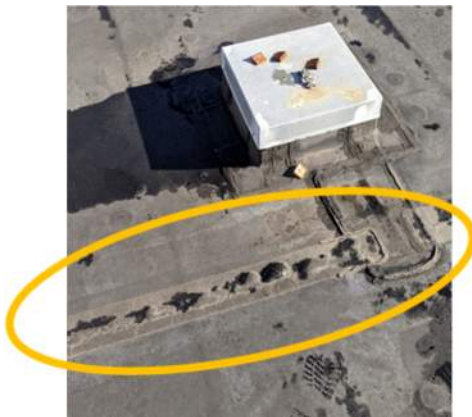
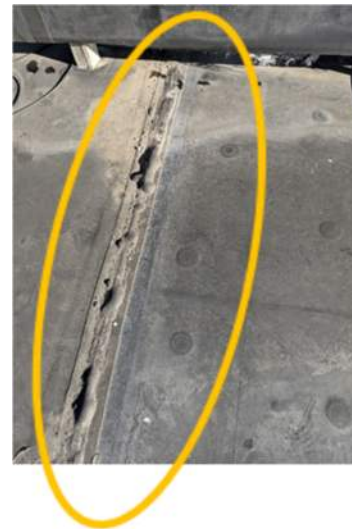
*Potential Cause:* Unsure as to why the seam tape is showing bubbles. The seal appears to be intact at time of observation.

*Recommendation:* Contact installer to evaluate, remove existing bubbled seam tape and install new. Continue to inspect and monitor to ensure the seam stays sealed and bubbles do not pop.

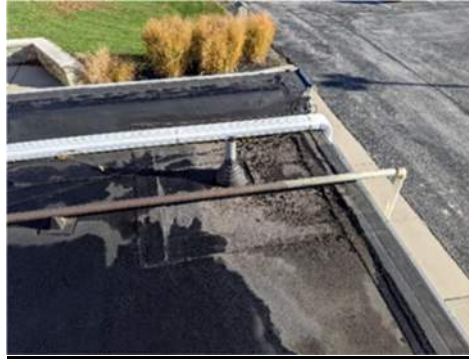
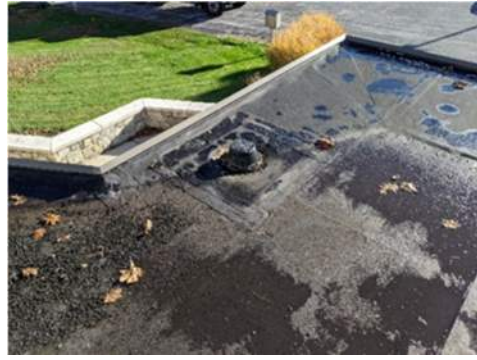
**Item 1.2      Debris, dirt and gravel build up**

*Potential Cause:* Exposed weather conditions and time.

*Recommendation:* Periodically clean debris from roof and around drains to maintain proper drainage.

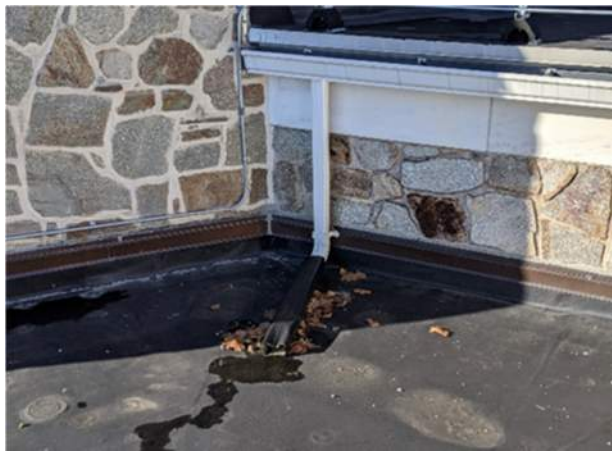
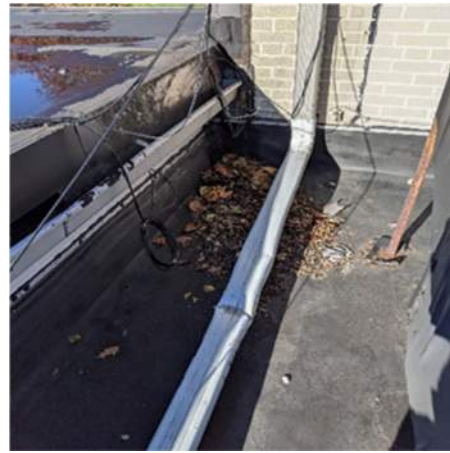
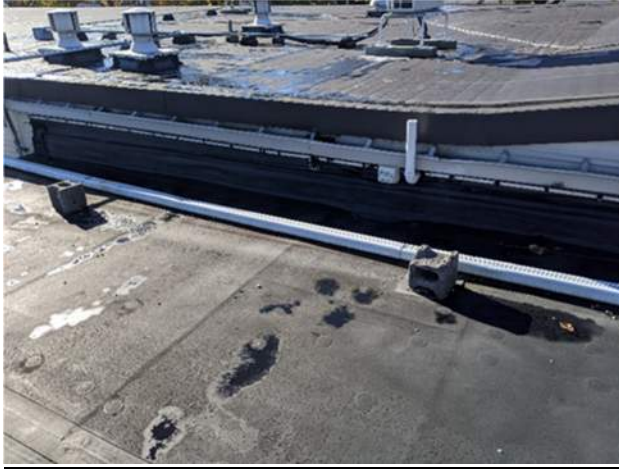
**Item 1.3      Downspout replacement**

*Potential Cause:* Exposed weather conditions, human traffic.

*Recommendation:* Replace portions of crushed or bent downspouts. If using concrete blocks to support and tilt downspouts, protective pad should be used to protect roof membrane from punctures and wear.

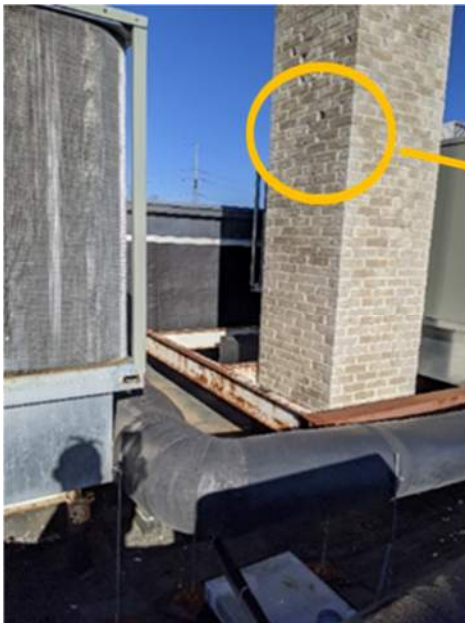
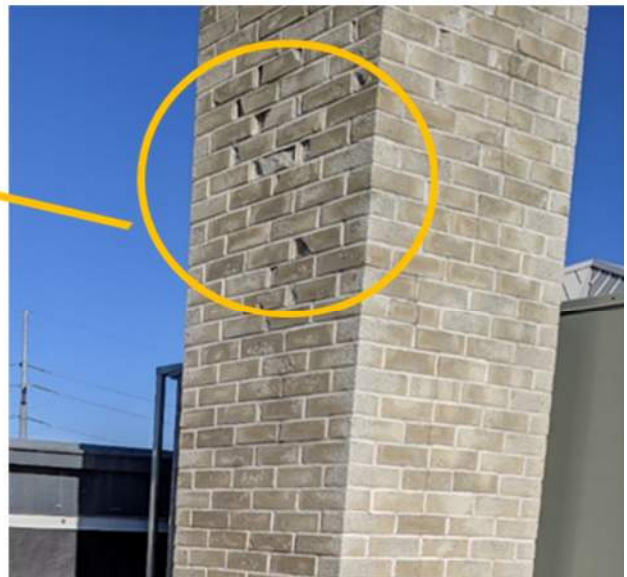
**Item 1.4 Chimney brick shows wear, but appears to be in good condition**

*Potential Cause:* Exposed Weather conditions and age of materials.

*Recommendation:* Periodically inspect chimney for signs of further wear and deterioration.

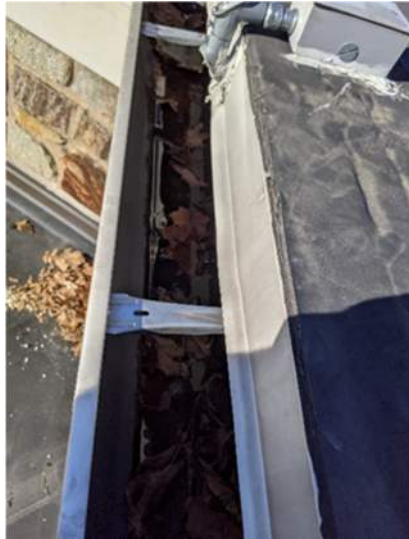
**Item 1.5**

**Clean gutters**

*Potential Cause:* Exposed weather conditions and time.

*Recommendation:* Periodically clean leaves and debris from gutters to ensure proper drainage flow.

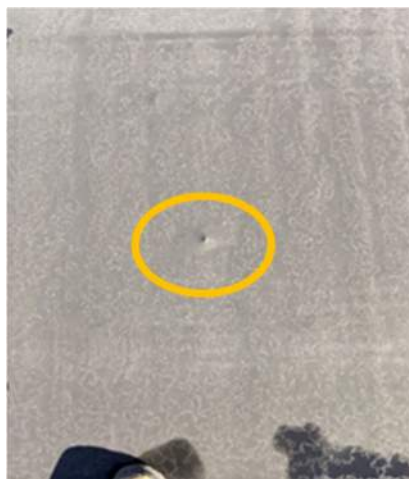
**Item 1.6**

**Puncture in roof membrane**

*Recommendation:* Puncture should be patched.

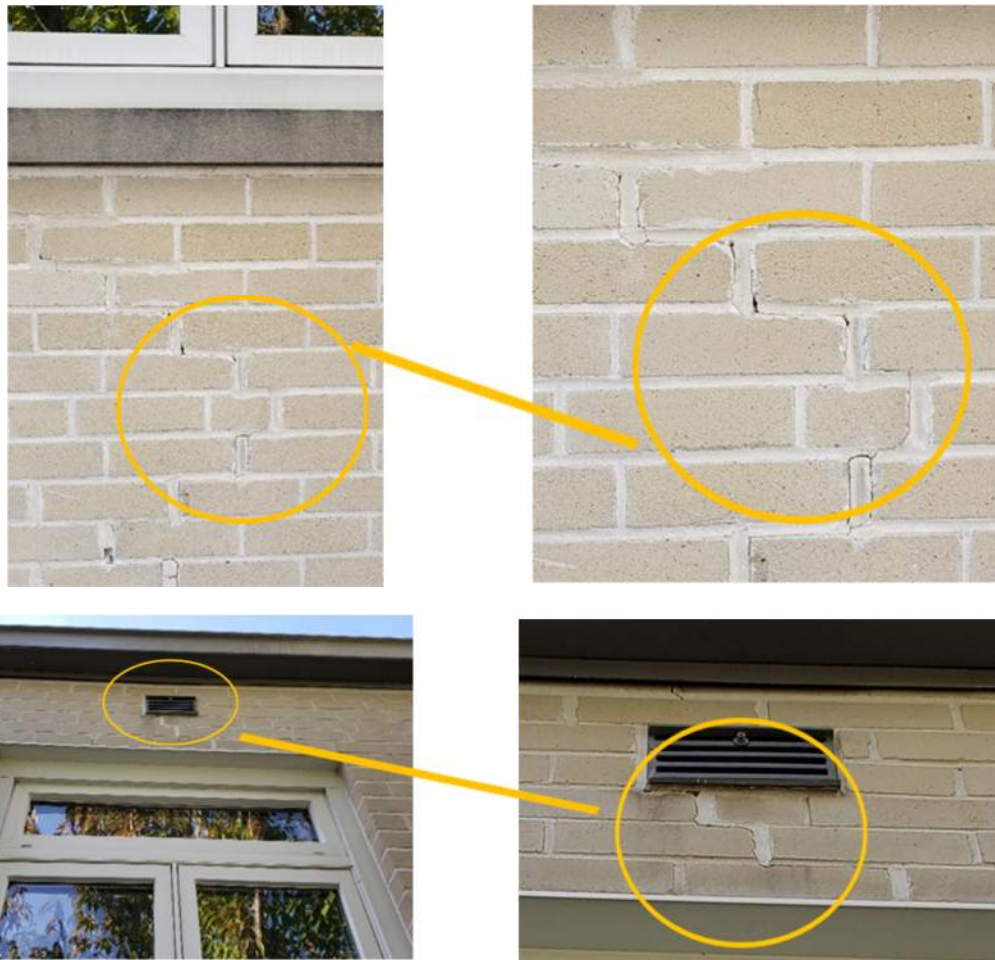
### Item 2.1 Step cracking in brick

*Potential Cause:* Movement due to thermal expansion and contraction or possible foundation settlement. Current construction practice recommends expansion joints at no more than 30'-0" on center, at openings, and within 3'-0" of a wall corner, however, no expansion joints were noted in the existing walls. There are no signs indicating an immediate structural failure is occurring, for example, differential settlement of foundations, large (greater than ¼") vertical cracking, or horizontal cracking.

| Item 2.1 | Step cracking in brick | continue to monitor, \$2000-\$4000 |

*Recommendation:* There are two options to consider: (1) Further investigation including crack monitoring or subsurface investigation to confirm the probable cause of cracking, or (2) Cut expansion joints and repoint.

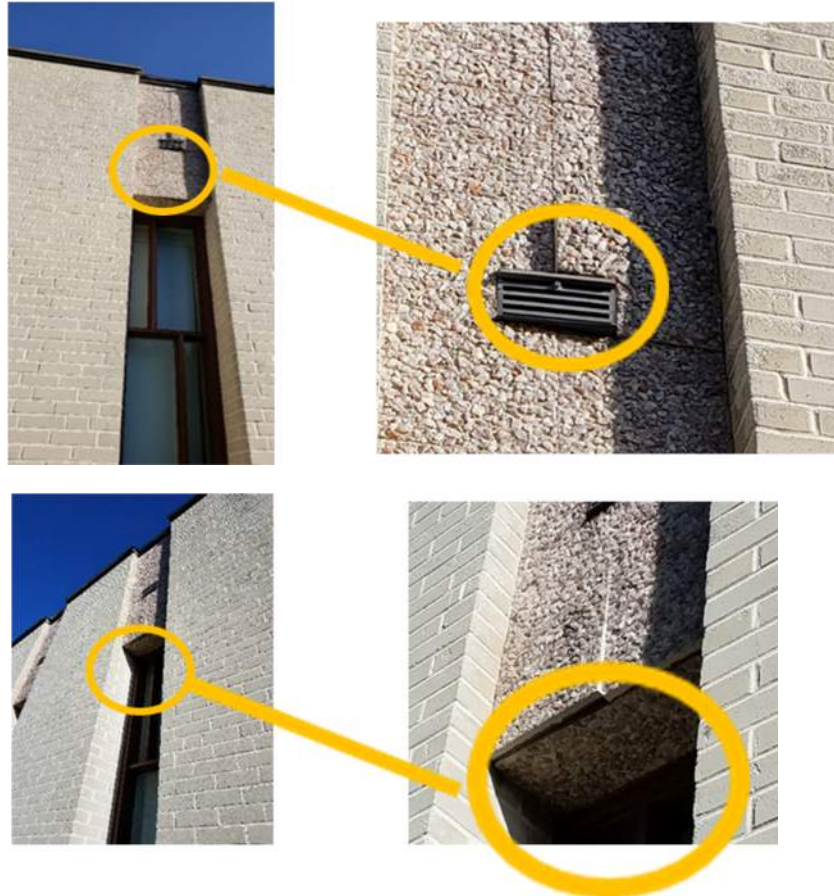
### Item 2.2      Precast panel movement

*Potential Cause:* Thermal expansion and contraction action, settlement, previous replacement. Large, unsealed gaps allow water to penetrate wall system.

*Recommendation:* Remove precast panel and clean surface. Patch panel to match adjacent surfaces.

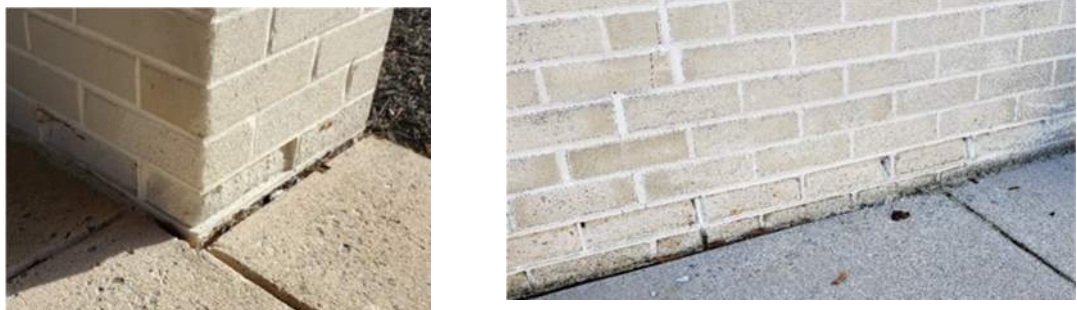
### Item 2.3      Brick deterioration at wall base

*Potential Cause:* De-icing agents used on walking paths, snow being piled against brick walls.

| Item 2.3 | Brick deterioration at wall base | continue to monitor |

*Recommendation:* Continue to monitor. If in the future, integrity is compromised, remove and replace.

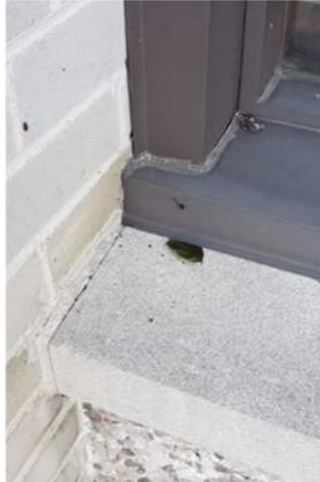
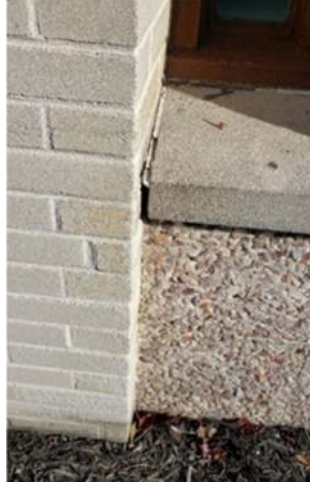
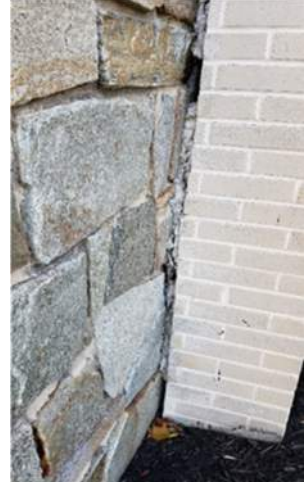
**Item 2.4 Sealant deterioration around windows and doors, in between panels, at intersecting materials**

*Potential Cause:* Exposed weather conditions and age of materials.

| Item 2.4 | Sealant deterioration | general maintenance item |

*Recommendation:* Remove sealant and any backer material completely. Clean joint to prepare for new joint. Install new backer material and apply sealant. Make sure the joint sealant will provide the proper adhesion to the materials it will contact. Consider installation time (Fall/Spring), when joint should be at the “in-between” point of movement. Allow sealant to cure properly.

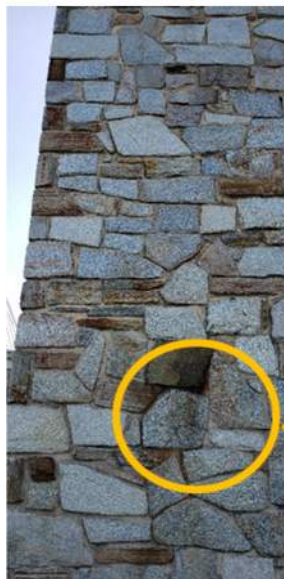
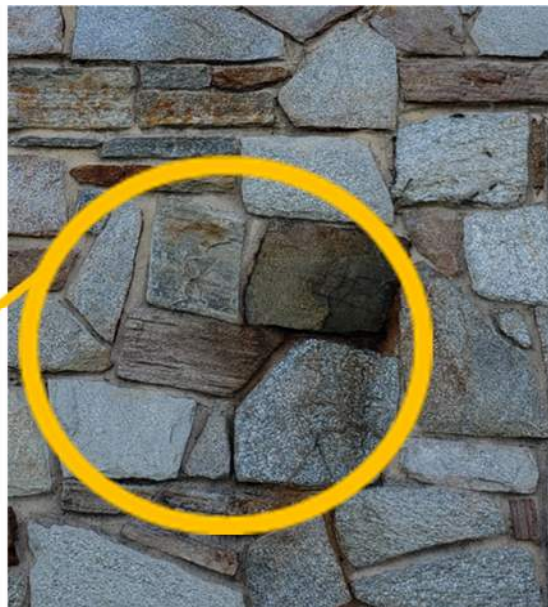
**Item 2.5 Stone deterioration**

*Potential Cause:* Exposed weather conditions and age of materials.

| Item 2.5 | Stone deterioration | continue to monitor |

*Recommendation:* No immediate fix. Continue observation for any change.

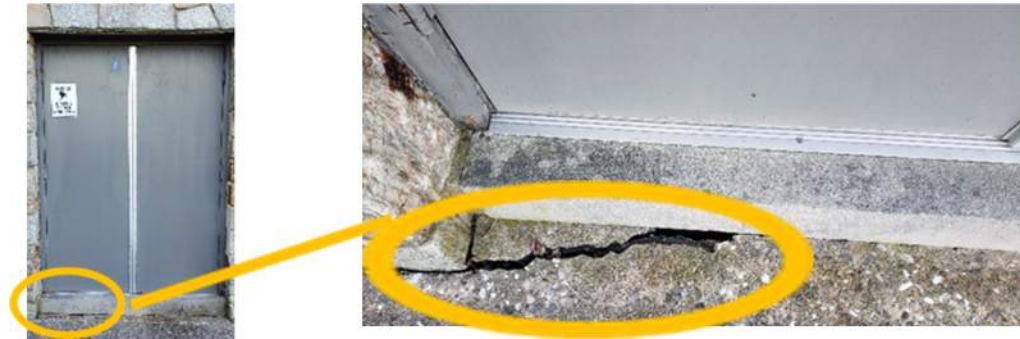
**Item 2.6**

**Concrete slab separated from wall and allows water through**

*Potential Cause:* Settlement, freeze/thaw action.

*Recommendation:* There are two options to consider: (1) Remove and replace, or (2) Patch and seal crack to be weathertight.

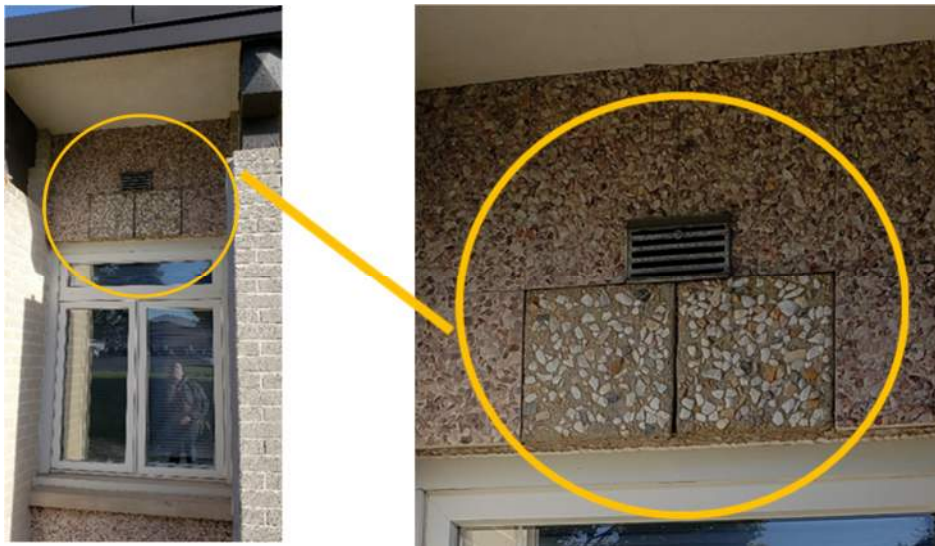
**Item 2.7**

**Precast panel gaps**

*Potential Cause:* Panels cut and installed after initial construction. Large, unsealed gaps allow moisture to penetrate wall system.

*Recommendation:* Clean joints and provide backer rod and sealant for weathertight seal.

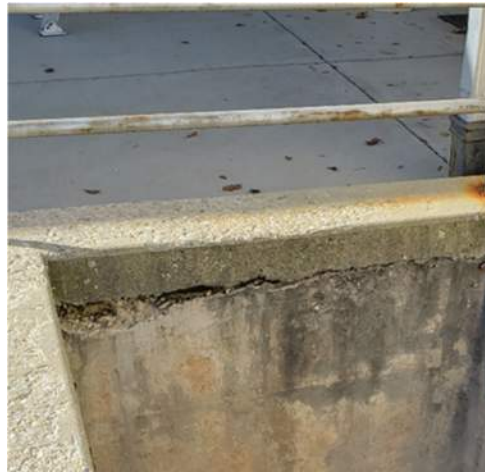
### Item 3.1 Concrete deterioration

*Potential Cause:* Water infiltration, de-icing agents, freeze/thaw action, corrosion.

| Item 3.1 | Concrete deterioration | \$500-\$1500 |

*Recommendation:* Patch concrete using standard concrete repair materials and manufacturer's recommendations.

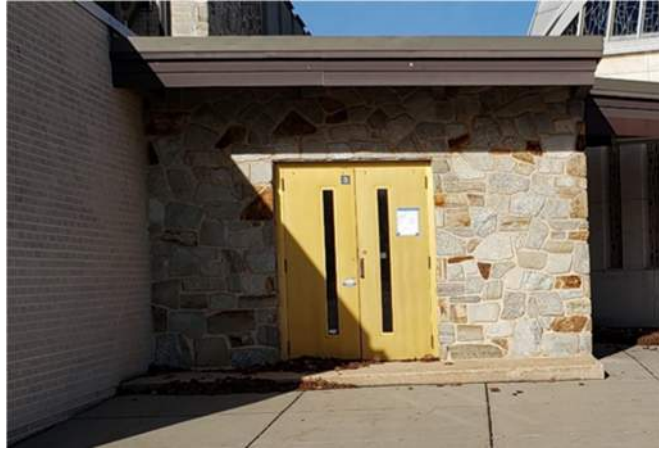
**Item 4.3**

**Several existing exterior doors have non-compliant sill conditions**

| Item 4.3 | Exterior doors: non-compliant sill conditions | \$750-\$2500 per location |

*Recommendation:* Provide code-compliant sills. Options to consider are to provide new sills, ramp/slope access, etc.

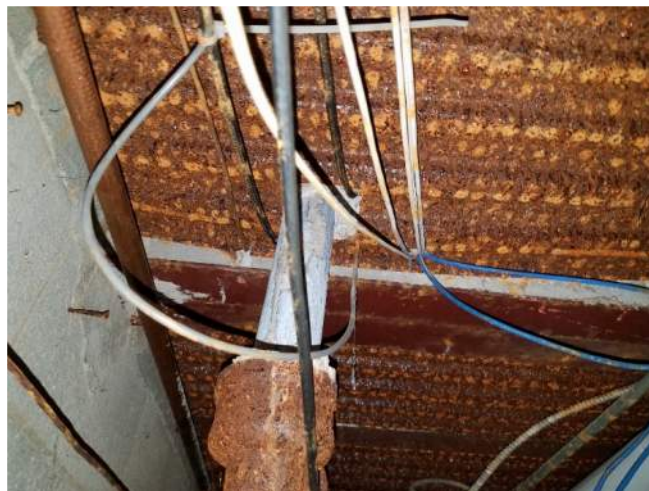
- a) Significant steel deck and lintel rust was noted, as well as deterioration of utilities, conduits, and supports.
- b) Based on the existing building drawings provided by Beth Israel, the reinforced four (4) inch concrete slab is adequate to span the pipe trenches.

- a) Clean and repaint the lintels to provide protection against moisture in the trenches.

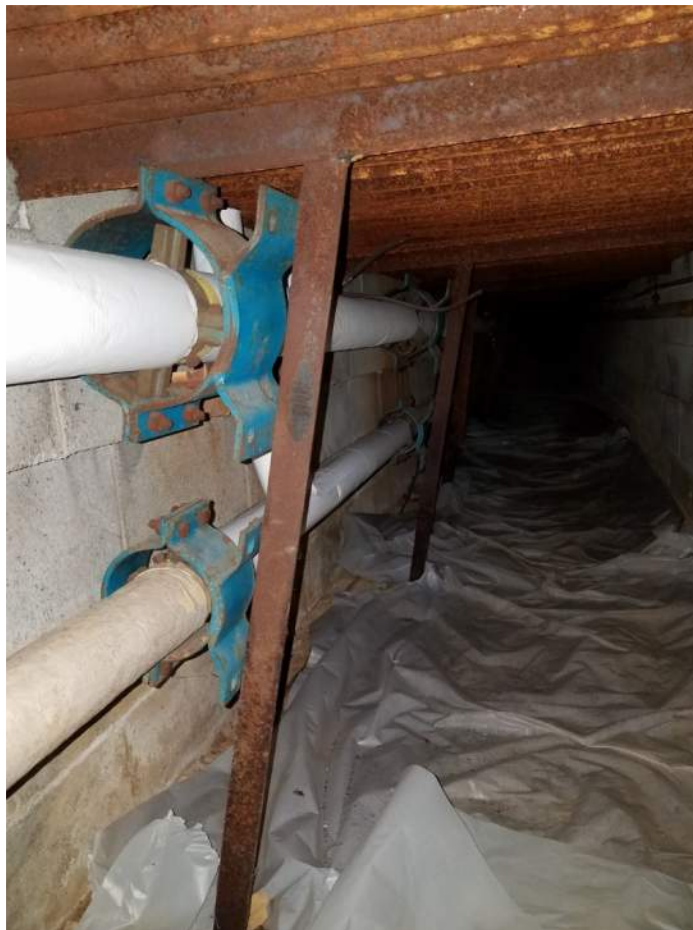
## B. Pipes and Utilities in Pipe Trenches

1. Description
  - a) Located in underslab pipe trenches were supported by a combination of steel angles and hangers.
2. Deficiencies
  - a) These supports showed signs of significant rust, as did some areas of the utilities.
3. Code Violations
  - a) No code violations found
4. Recommended Action
  - a) Monitor the pipe supports and utilities for extensive deterioration and replace as required to maintain utility systems and support.
5. Probable Construction Cost
  - a) Include allowance with yearly maintenance budget

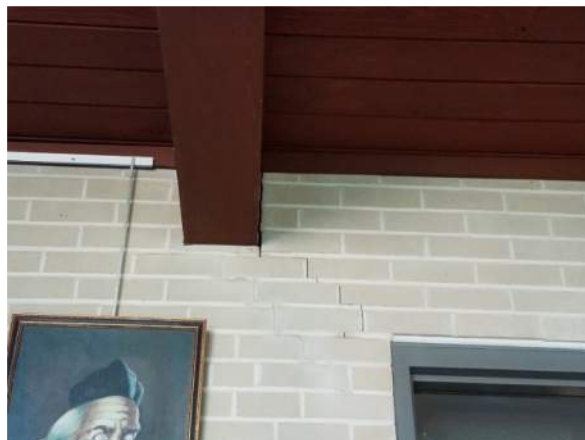
- a) At one (1) beam bearing location in the Education Building main vestibule, a step crack was noted in the brick below a steel beam bearing location that is located next to an interior door opening. Current construction practice recommends installing expansion joints at a maximum of 30'-0" on center, at wall openings, and within 3'-0" of wall corners. No joints were found in the existing construction, therefore we believe the step crack to be the result of thermal expansion and contraction of the wall.

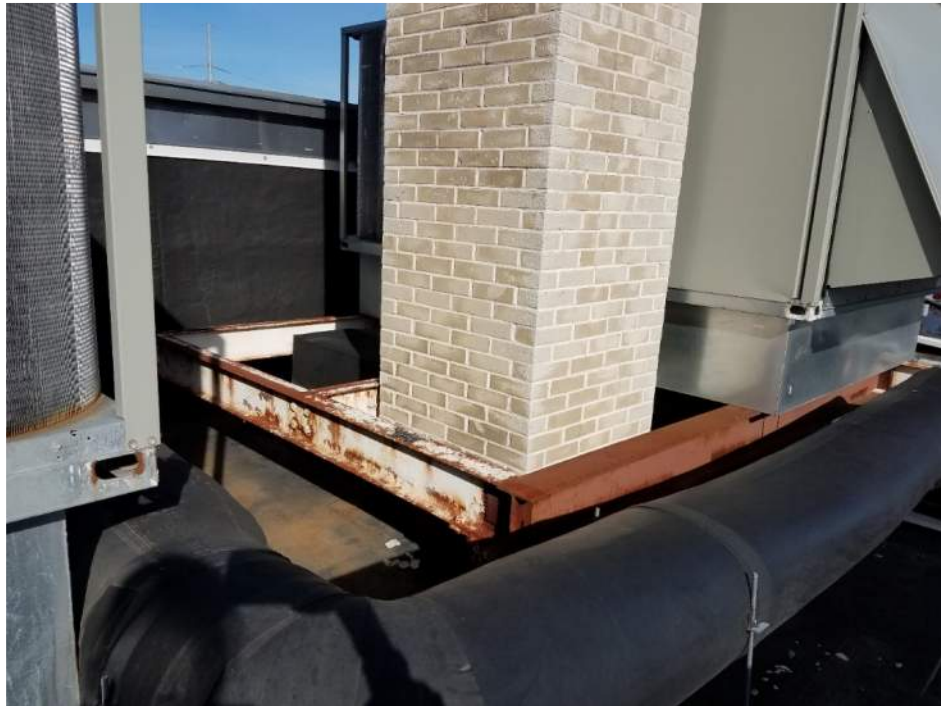
E. Rooftop Unit Dunnage

1. Description
  - a) Consists of steel wide flange shapes supporting existing rooftop units.
2. Deficiencies
  - a) Significant rust was noted on most of the dunnage members.
3. Code Violations
  - a) No code violations found
4. Recommended Action
  - a) Clean and repaint the dunnage steel to increase the lifespan of the support members.
5. Probable Construction Cost
  - a) \$5,000-\$8,000
