# Facilities Condition Assessment

**Temple Beth Israel  
2090 Hollywood Drive  
York, PA**

**JDB Engineering, Inc.  
PO Box 22160  
York, PA 17402  
Phone: 717-757-5602**

December 8, 2020  
Copyright © 2020

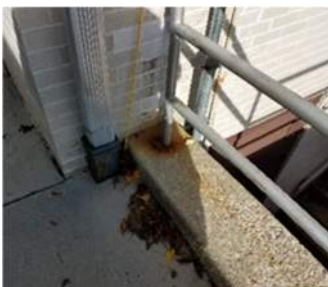
### Item 3.2 Steel railing is showing signs of deterioration and rust

*Potential Cause:* Exposed weather conditions, de-icing agents.

*Recommendation:* Replace any railings that are not structurally sound. Where railings are acceptable, clean, prepare surface, and provide new finish.

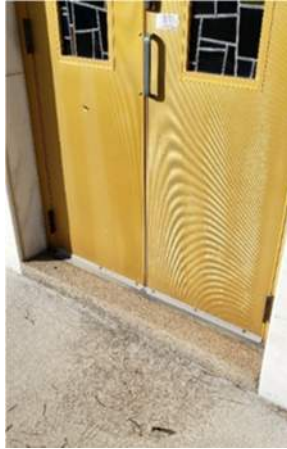
**Item 4.3**

**Several existing exterior doors have non-compliant sill conditions**

*Recommendation:* Provide code-compliant sills. Options to consider are to provide new sills, ramp/slope access, etc.

| Item 4.3 | Exterior doors: non-compliant sill conditions | \$750-\$2500 per location |

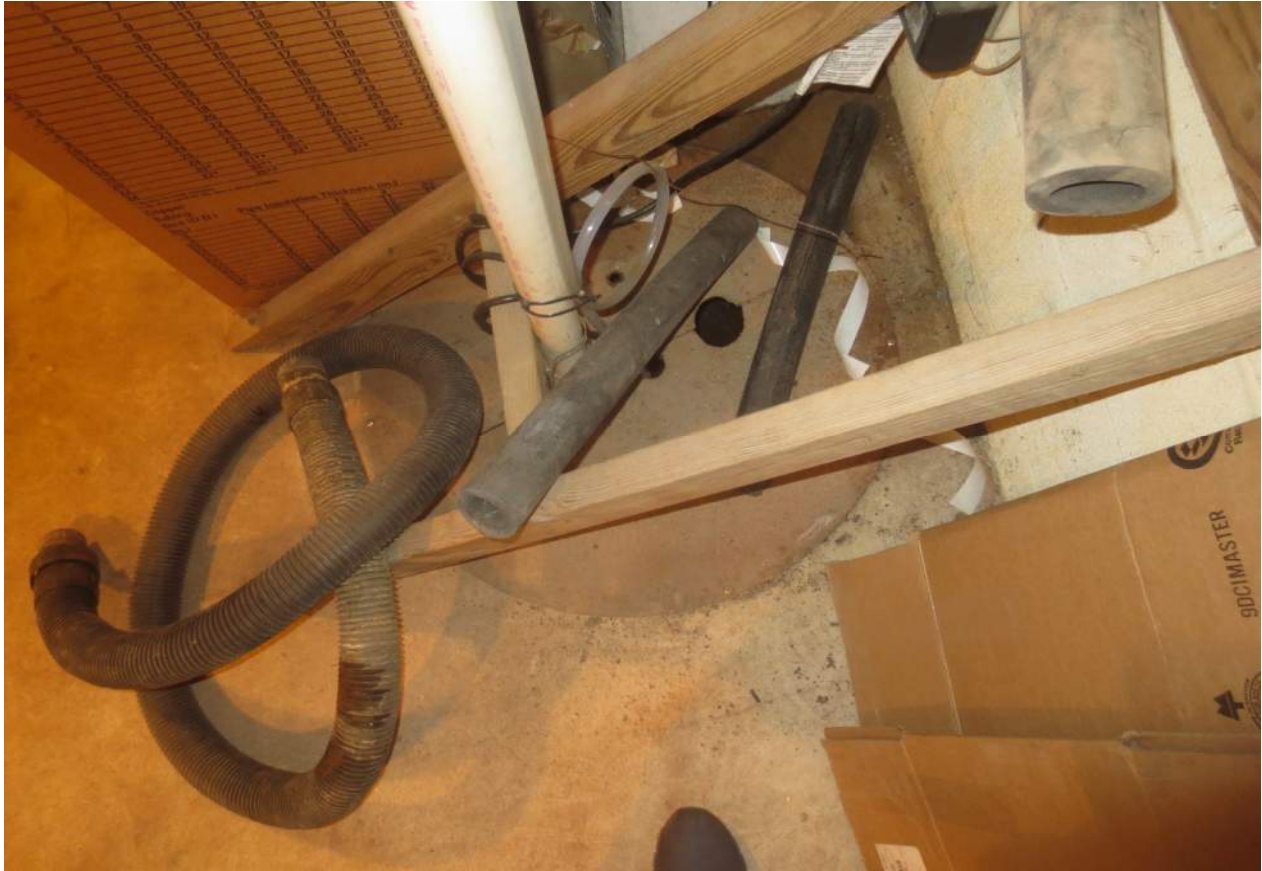
| <b>Equipment Tag</b> | SP-1 | <b>Condition</b> | Fair |

| <b>Equipment Type</b> | Sump Pump | <b>Year Built</b> | 8/19/2003 |

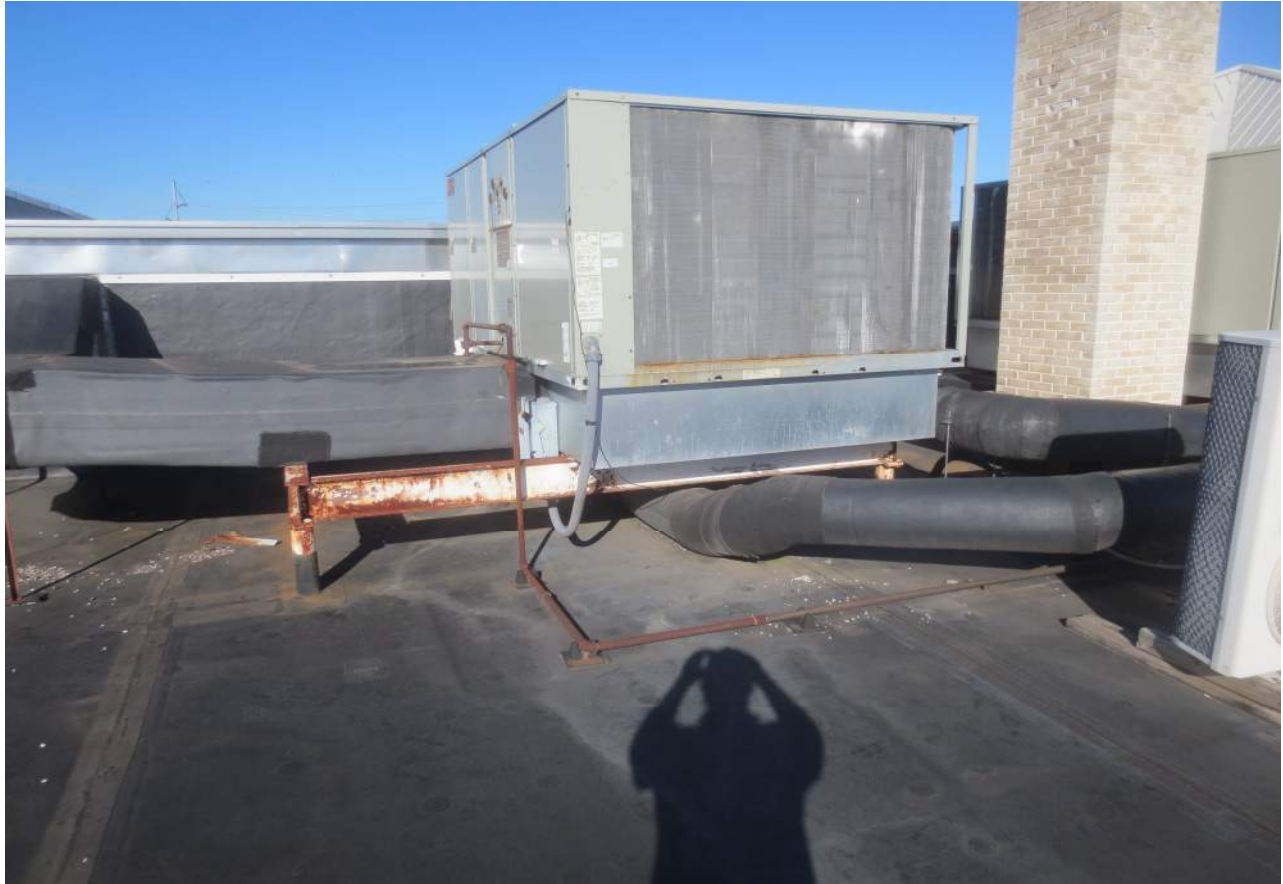
| <b>Equipment Type</b> | Rooftop Air Conditioning Unit | <b>Year Built</b> | 7/1/2010 |

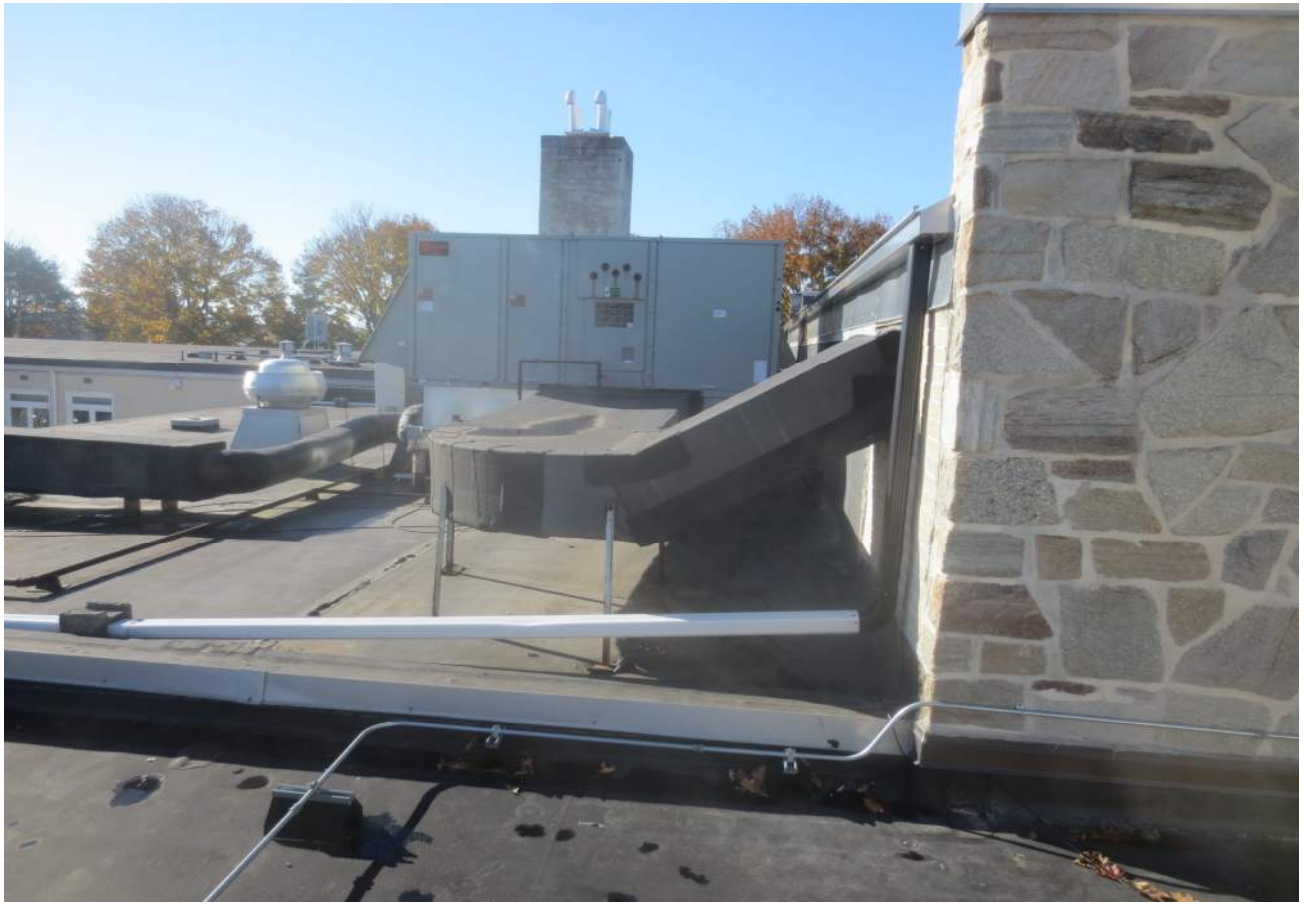
| <b>Equipment Type</b> | Rooftop Air Conditioning Unit | <b>Year Built</b> | 7/1/2010 |

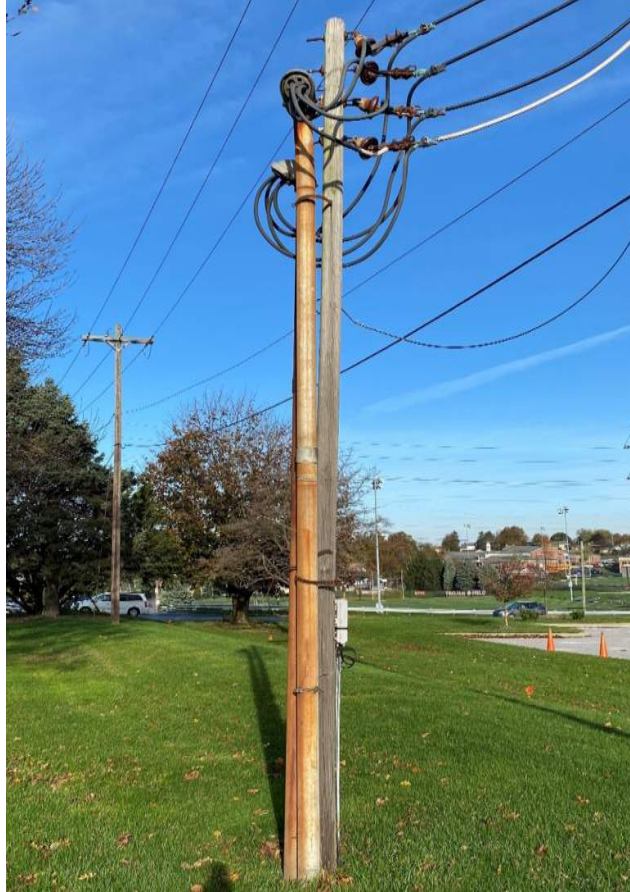
| <b>System Type</b> | Electrical Distrubution | <b>Equipment Type</b> | Utility Pole |
| <b>Equipment Tag</b> | None | <b>Condition</b> | Poor / Operating |

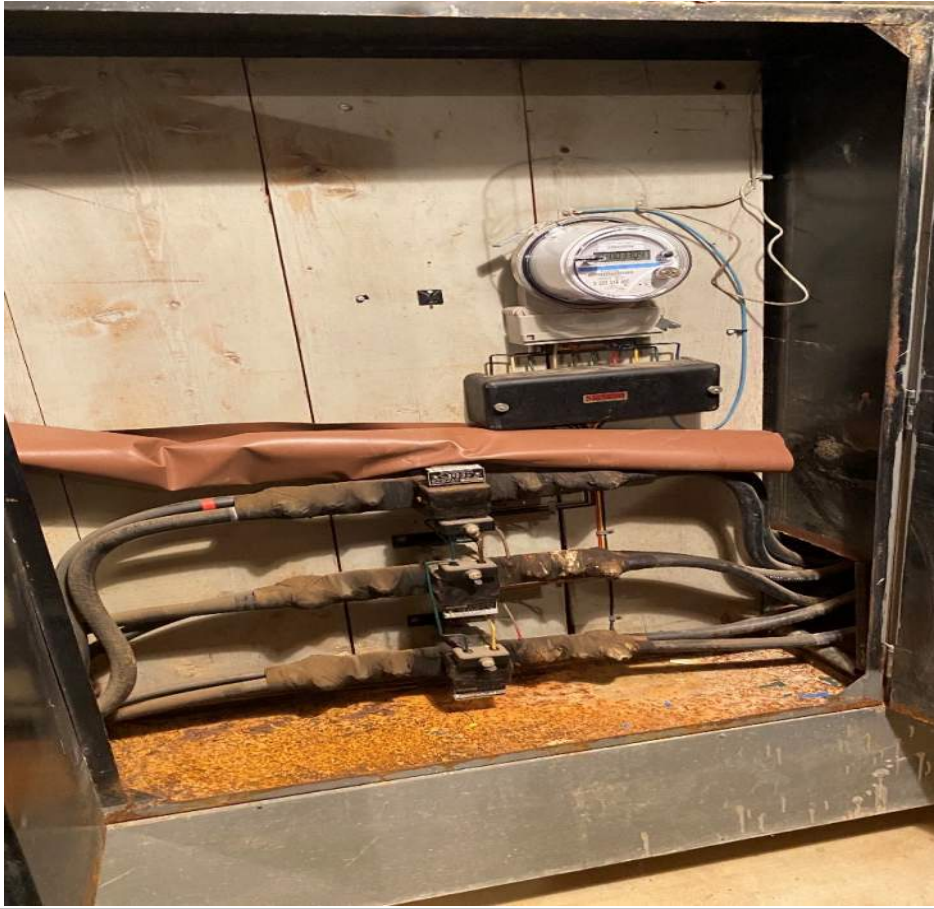
| <b>System Type</b> | Electrical Distrubution | <b>Equipment Type</b> | CT Metering Cabinet |

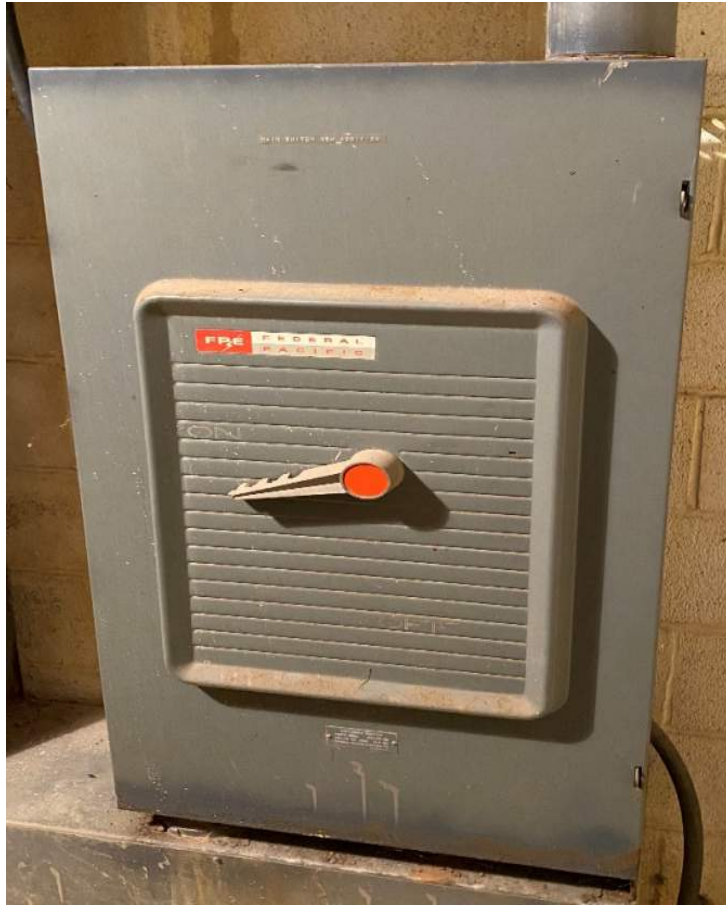
| <b>Equipment Tag</b> | Switch for Panel H - Addition | <b>Condition</b> | Fair / Operating |

| <b>Additional Comments</b> | Signs of surface rust due to ambient moisture. | | |

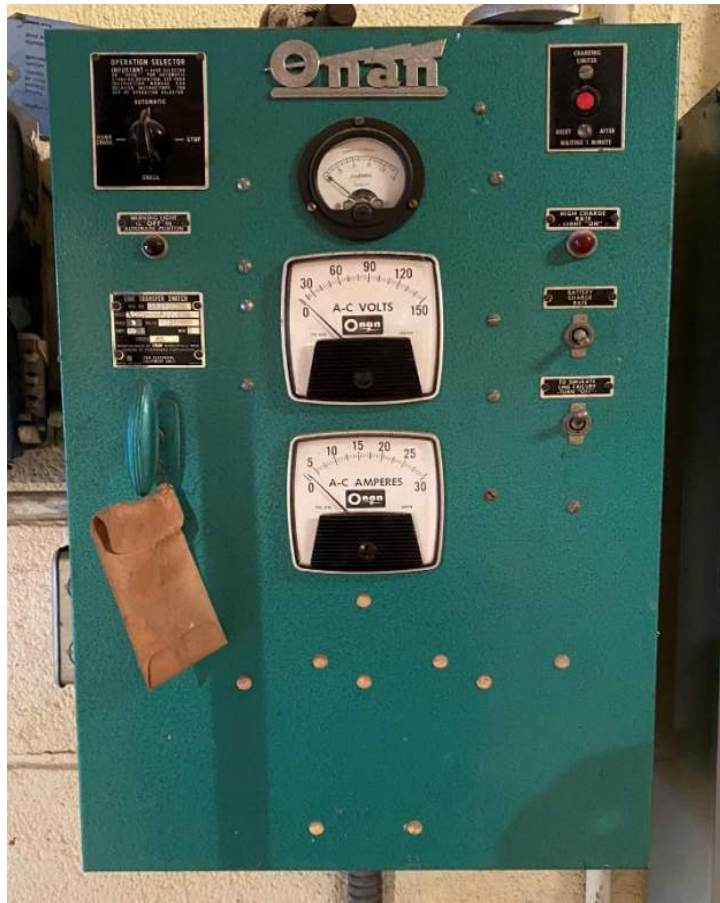
| <b>Equipment Tag</b> | None | <b>Condition</b> | Good |

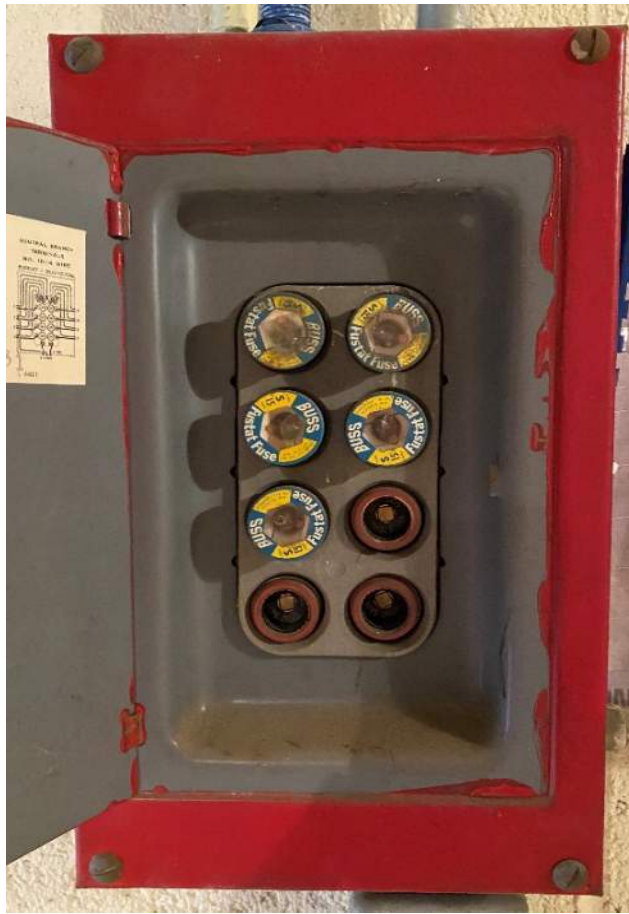
| <b>Equipment Tag</b> | None | <b>Condition</b> | Fair / Operating |
